ATTACHMENT TO L-2274
16 November 1966
Page 1

STATUS OF ROUTE 110
LAOS

NATIONAL PHOTOGRAPHIC INTERPRETATION CENTER

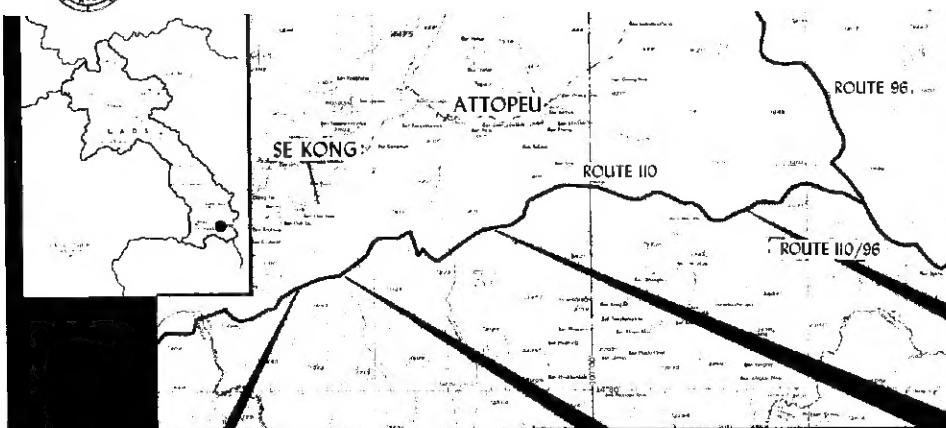
14-41N 107-09E

110 TO BE IN A STATE OF DISUSE BETWEEN 1435N 10636E (UTM XB734135), WHERE A TRAIL CROSSES THE ROAD, AND 1441N 10709E (UTM YB324261), WHERE THE ROAD IS SEVERELY WASHED OUT. ROAD INTERDICTIONS ARE NOTED AT THE FOLLOWING LOCATIONS: 1436N 10638E (UTM XB762147), 1437N 10639E (UTM XB783168), AND 1437N 10642E (UTM XB846183). NONE OF THESE INTERDICTIONS HAVE BEEN BY-PASSED. SOME MAJOR FORDS ALONG THIS ROUTE WHICH SHOW NO SIGNS OF RECENT USE ARE LOCATED AT 1438N 10642E (UTM XB847186), 1439N 10650E (UTM XB979213), 1443N 10700E (UTM YB167288), AND 1442N 10707E (UTM YB292264).

SEVERE EROSION
